# **Arbeitsbericht NAB 21-20**

**TBO Marthalen-1-1:  
Data Report**

**Dossier I  
Drilling**

September 2021

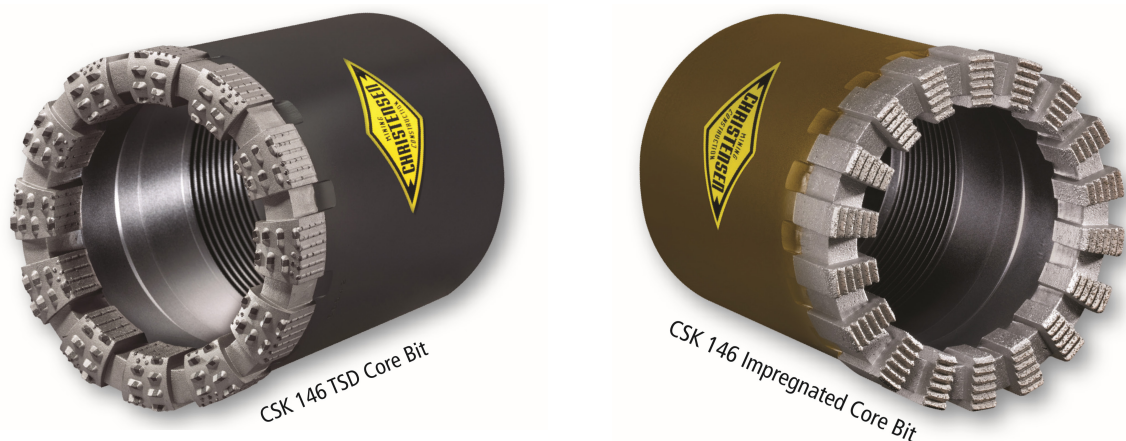
This type of core bit is designed for medium hard to extremely hard formations, but also for less to very abrasive rocks. Multiple layers of synthetic diamond fragments are sintered into a hard metal matrix. This compound behaves self-sharpening during progressive abrasion. Worn diamonds are released and replaced by new ones, until the matrix compound is completely eroded. This core bit is available with different types of matrix.

For MAR1-1, impregnated core bits with a medium to soft matrix were chosen mainly for coring limestone, dolostone, anhydrite and sandstone. This type of matrix is designed for less abrasive but hard, fine-grained and homogeneous formations.

Fig. 2-1: Synset core bit (left) and impregnated core bit (right)

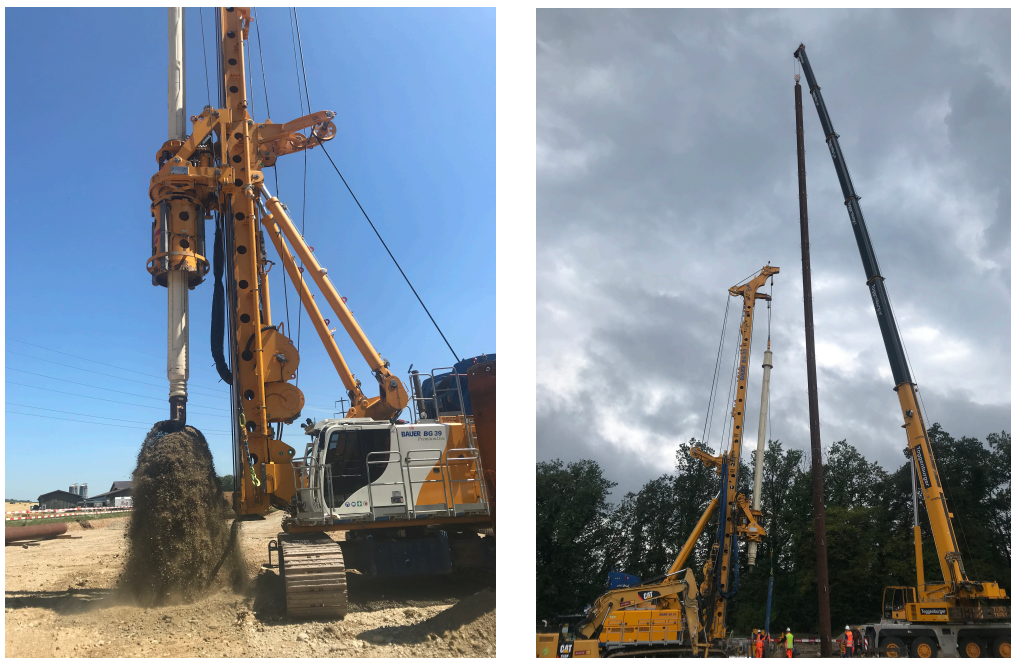
Because of the good ground conditions, it was not necessary to build a separate foundation for the conductor drilling rig. Conductor drilling operations were carried out on the very stable and pebbly ground (see Fig. 3-1). A 1'194 mm diameter hole was drilled dry through 48.5 m of Quaternary sediments and an additional 6.5 m of solid formations of the Untere Süsswassermolasse. The 30" (762 mm) conductor pipe was welded and equipped with centralisers on the surface and then installed in one piece down to a depth of 55 m MD (see Fig. 3-1). The conductor was adjusted for verticality with several spirit levels while the cementation was performed through the annulus between the formation and the steel pipe. Logging showed a vertical deviation below 0.3° and homogeneous cementation to all sides.

Fig. 3-1: Drilling (left) and installation (right) of the conductor

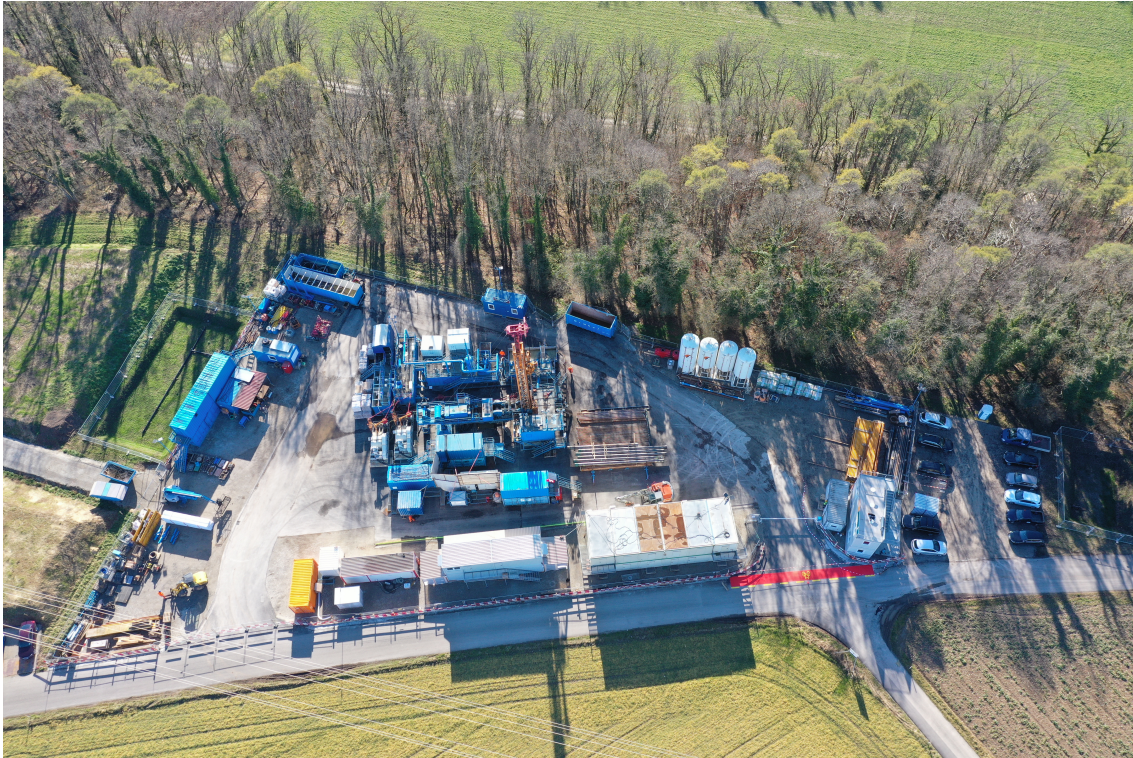
A construction plan, including plant management and arrangement of the drilling rig and its peripheral facilities, can be found in Appendix E. Fig. 3-2 shows the fully assembled drill site directly after construction.

Fig. 3-2: Drill site after installation of the drilling rig and peripheral facilities

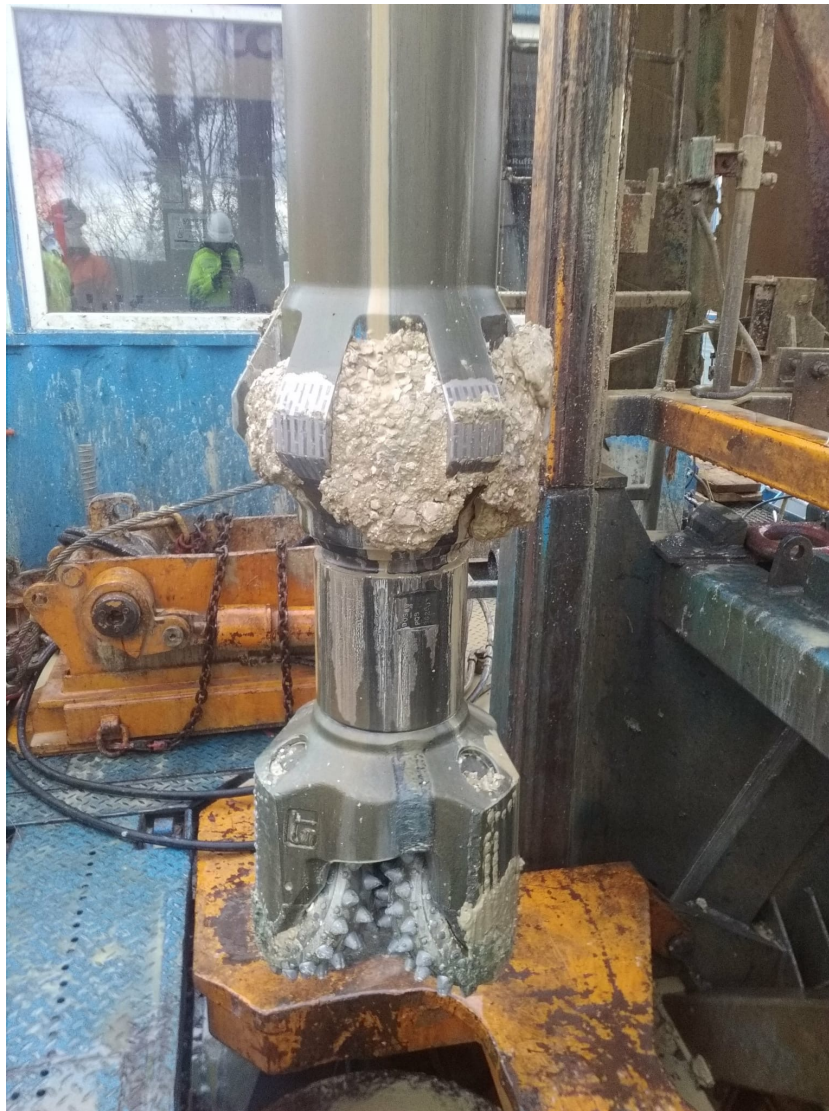
Section I was drilled destructively with a 17 $\frac{1}{2}$ " (444.5 mm) tricone bit and a 9 $\frac{5}{8}$ " mud motor (see Fig. 3-3). BHA #3 used for this section can be found in Appendix N. Cement was first drilled from 46 m to 57 m MD. Afterwards, the Untere Süsswassermolasse was drilled until 256 m MD and finally the upper part of the Malm until 309 m MD. Single shot measurements were taken every 50 m to check the verticality of the borehole. All measurements were below 1° inclination.

Fig. 3-3: 17½" tricone bit and 9⅝" mud motor after POOH

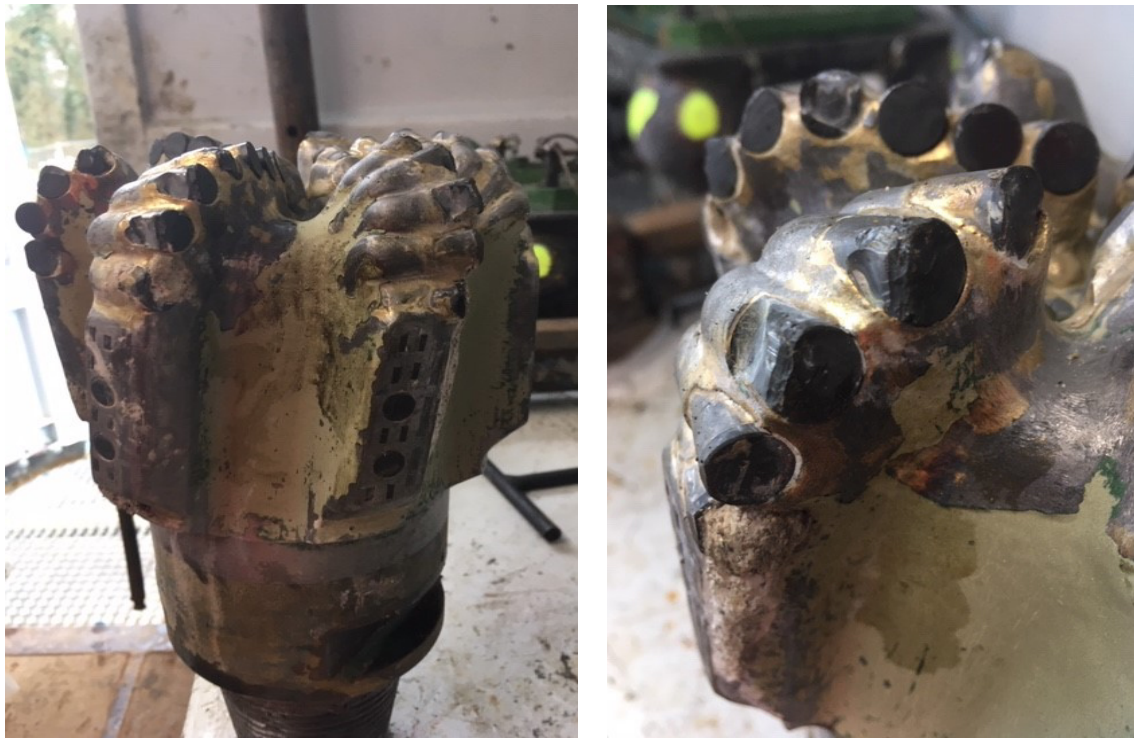
The 6½" PDC bit was heavily worn after drilling 148 m of limestone, which can be seen in Fig. 3-4.

Fig. 3-4: 6½" PDC bit after POOH

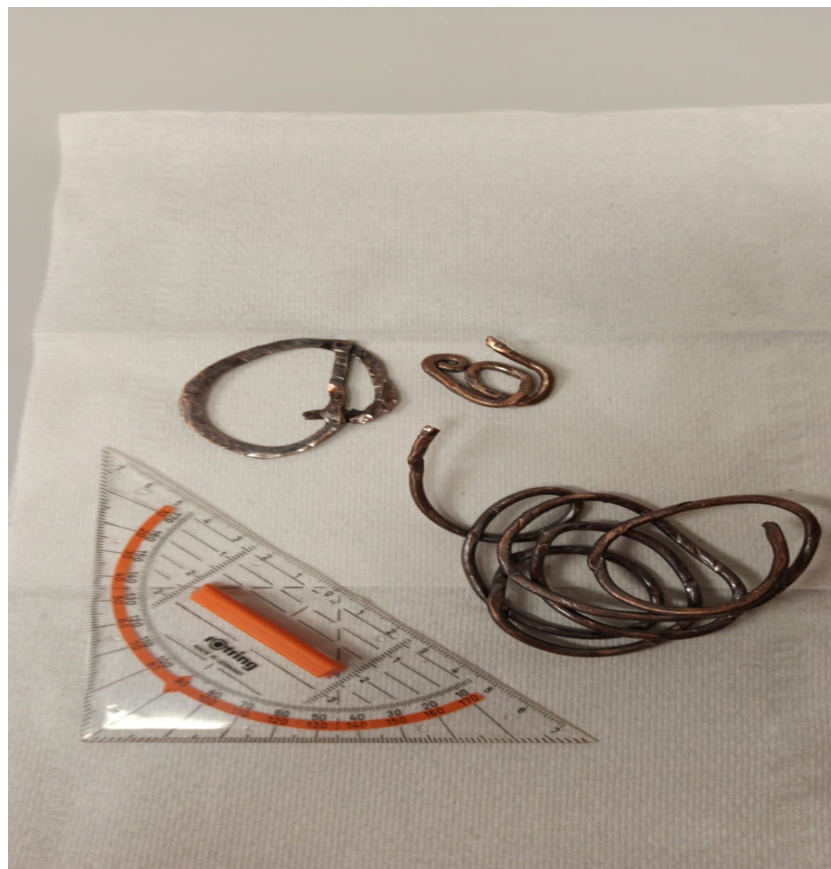
Fig. 3-5: Junk in hole recovered from 463 m MD

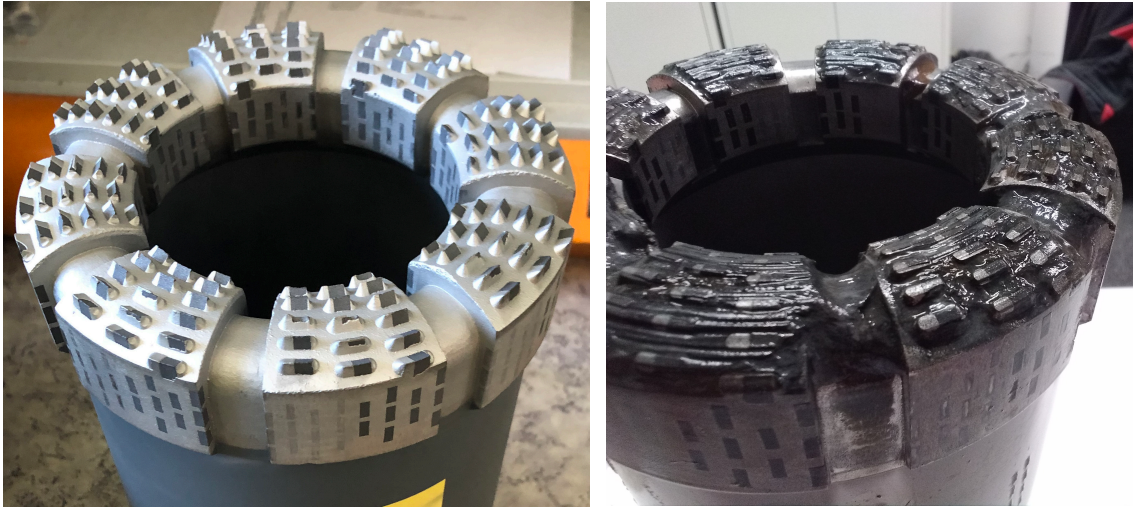
Coring operations continued to a depth of 655 m MD, including an additional bit trip as ROP was dropping constantly towards the end. The synset showed normal wear after POOH (see Fig. 3-7), which led to the decision to run another new synset core bit (see BHA #11 in Appendix N). This bit then cored until section TD at 750 m MD.

Fig. 3-7: Synset core bit before RIH (left) and after POOH (right) from a depth of 655 m MD

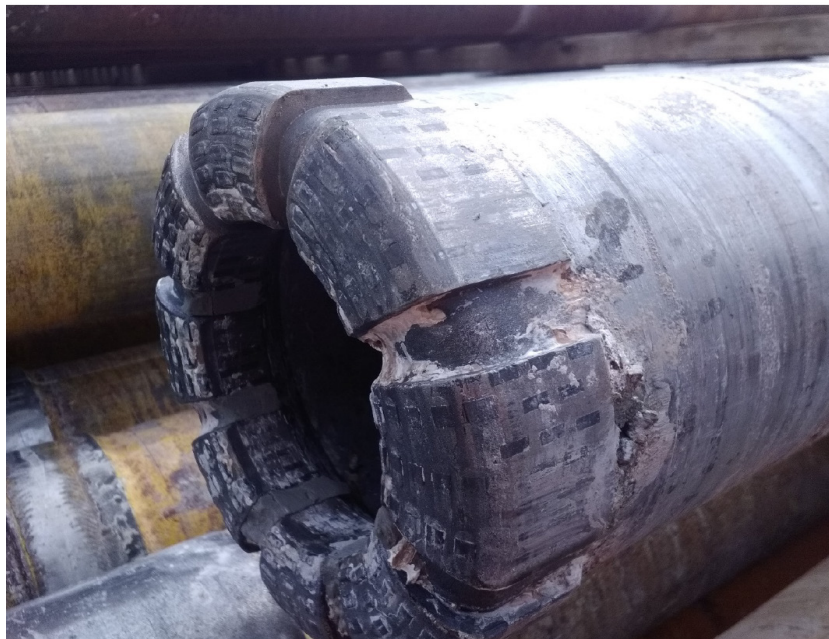
After performing a magnet run without any significant metal recovery, coring of Section III started using a synset core bit (see BHA #22 in Appendix N). Core length was fixed to 3 m as in the previous section. The synset bit cored until 796 m MD with constantly dropping ROP and was fully worn out after these 44 m (see Fig. 3-8).

Fig. 3-8: Synset core bit after POOH from the depth of 796 m MD

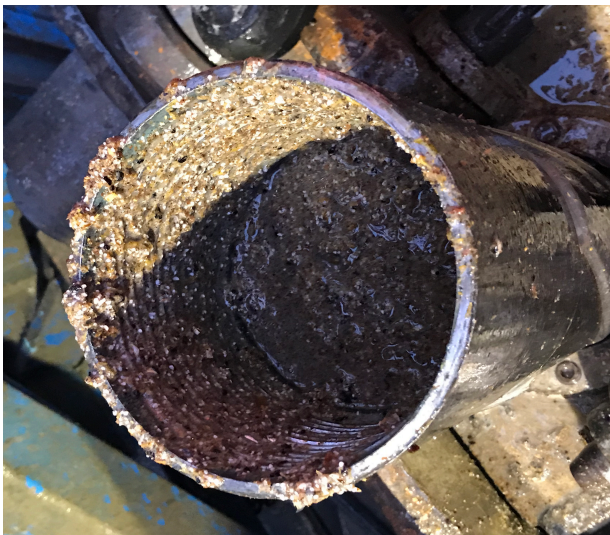
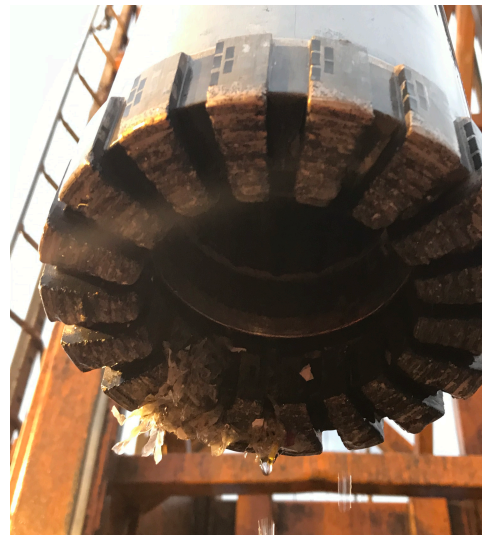
After the hydrotest, loss control operations using LCM started as soon as the coring string was back in the borehole. A total of 12 LCM pills had to be pumped before backflow and circulation were re-established. Nevertheless, completely sealing off the loss zone was not successful and the subsequent coring attempts failed. The surface and downhole equipment was contaminated and plugged with LCM (see Fig. 3-10) and had to be cleaned several times. The coring string also had to be pulled twice because the inner core barrel was not able to land on the outer core barrel and only small rock fragments were recovered after each coring attempt. There was no progress in coring because rock fragments became jammed within the inner core barrel. It was not possible to establish proper circulation due to an increase in the pumping pressure. The core bit was fully destroyed and completely lost its matrix (see Fig. 3-11).

Fig. 3-10: Equipment contaminated and plugged with LCM material

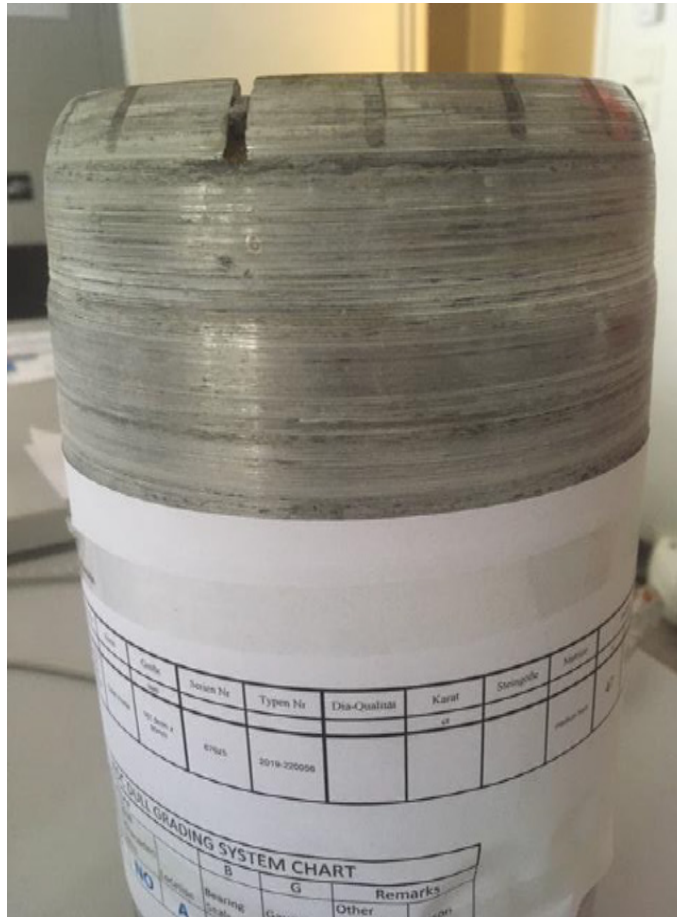
Fig. 3-11: Impregnated core bit fully destroyed without any matrix

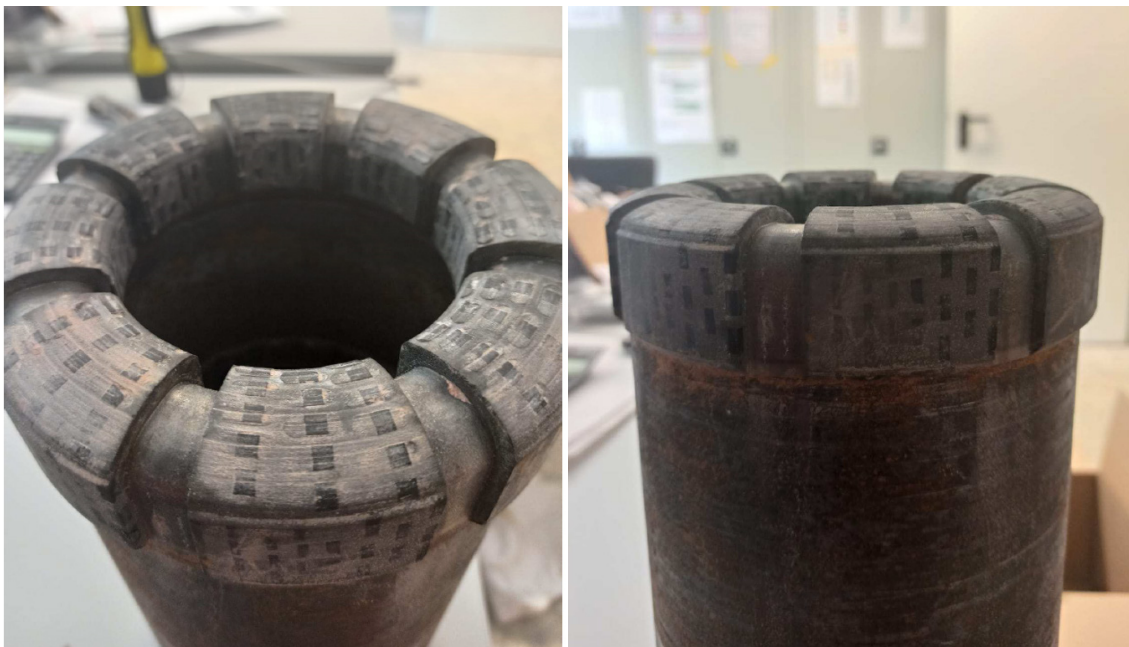
The mud exchange was conducted without any problems and coring operations resumed under dynamic losses of 60 L/min to 100 L/min until 1'054 m MD with fewer problems than before. Although the chloride content rose before the mud exchange, no salt layer was found in the Zeglingen Formation. The synset core bit was fully worn out after pulling out of hole (see Fig. 3-12).

Fig. 3-12: Synset core bit after pulling out of hole at a depth of 1'054 m MD

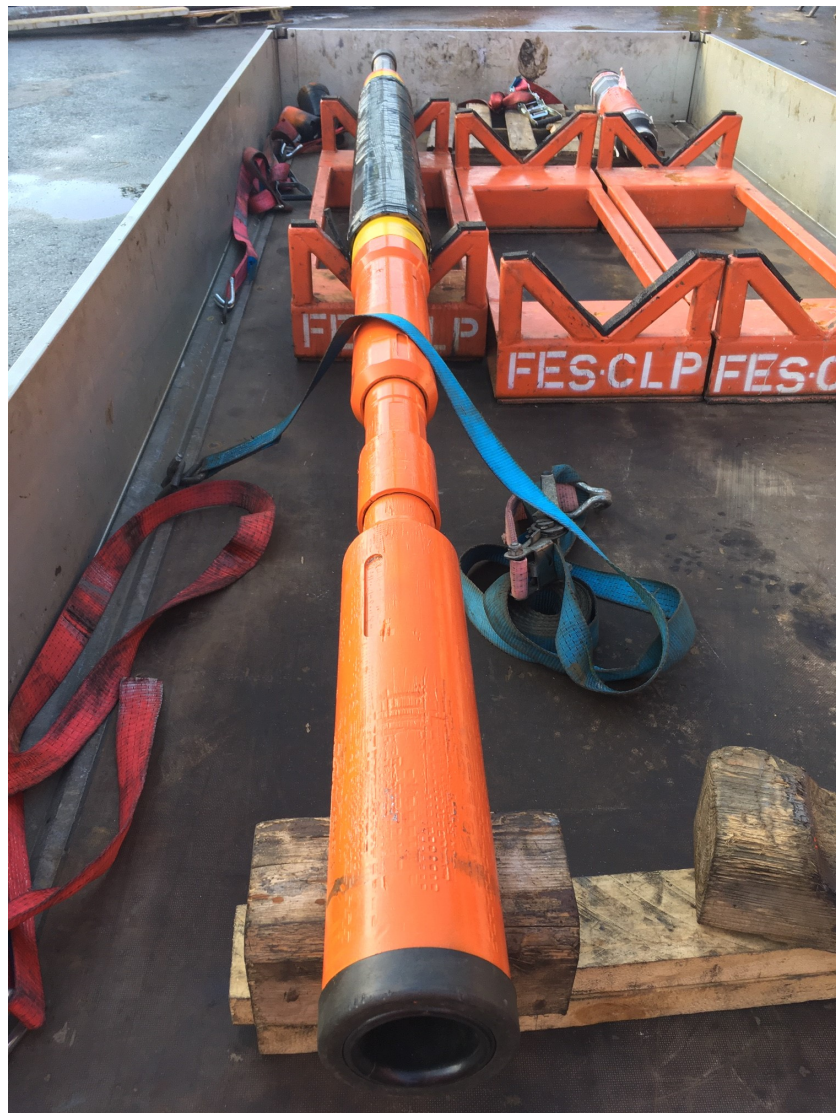
The next step was to set a 5½" open hole bridge plug (with turn release) at approximately 900 m MD (competent formation) above the lower loss zone and a second 5½" open hole bridge plug (with straight pull release, see Fig. 3-13) above the upper loss zone at approximately 865 m MD, also at a competent formation. It was planned to pull the upper bridge plug at a later stage to leave the Schinznach Formation open for potential long-term monitoring. After setting the two bridge plugs, the mud losses stopped immediately.

Fig. 3-13: 5½" open hole bridge plug with straight pull release

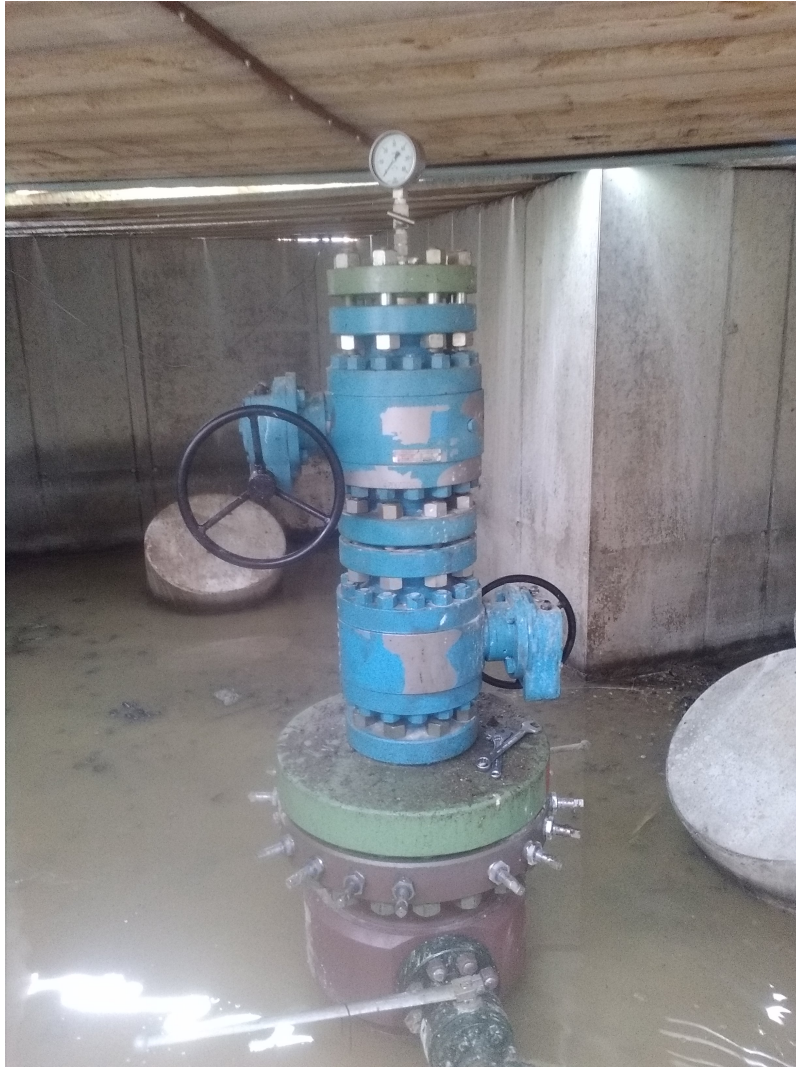
To finalise drilling operations in the MAR1-1 borehole, the saturated salt mud was displaced to a completion fluid (for pH regulation and corrosion protection) with MW 1.00 SG. Afterwards, the BOP stack was demounted and the wellhead (see Fig. 3-14) installed on the 13<sup>5</sup>/<sub>8</sub>" CHH (brown colour). This wellhead was equipped with two 4<sup>1</sup>/<sub>16</sub>" ball valves (blue colour), installed on a 3K double studded adapter flange (green colour) which serves as a crossover from 13<sup>5</sup>/<sub>8</sub>" to 4<sup>1</sup>/<sub>16</sub>".

Fig. 3-14: Wellhead installed after finishing drilling operations
